ground floor functional-utility program

detail - facade cross-section

exterior perspective - from the Merianplatz

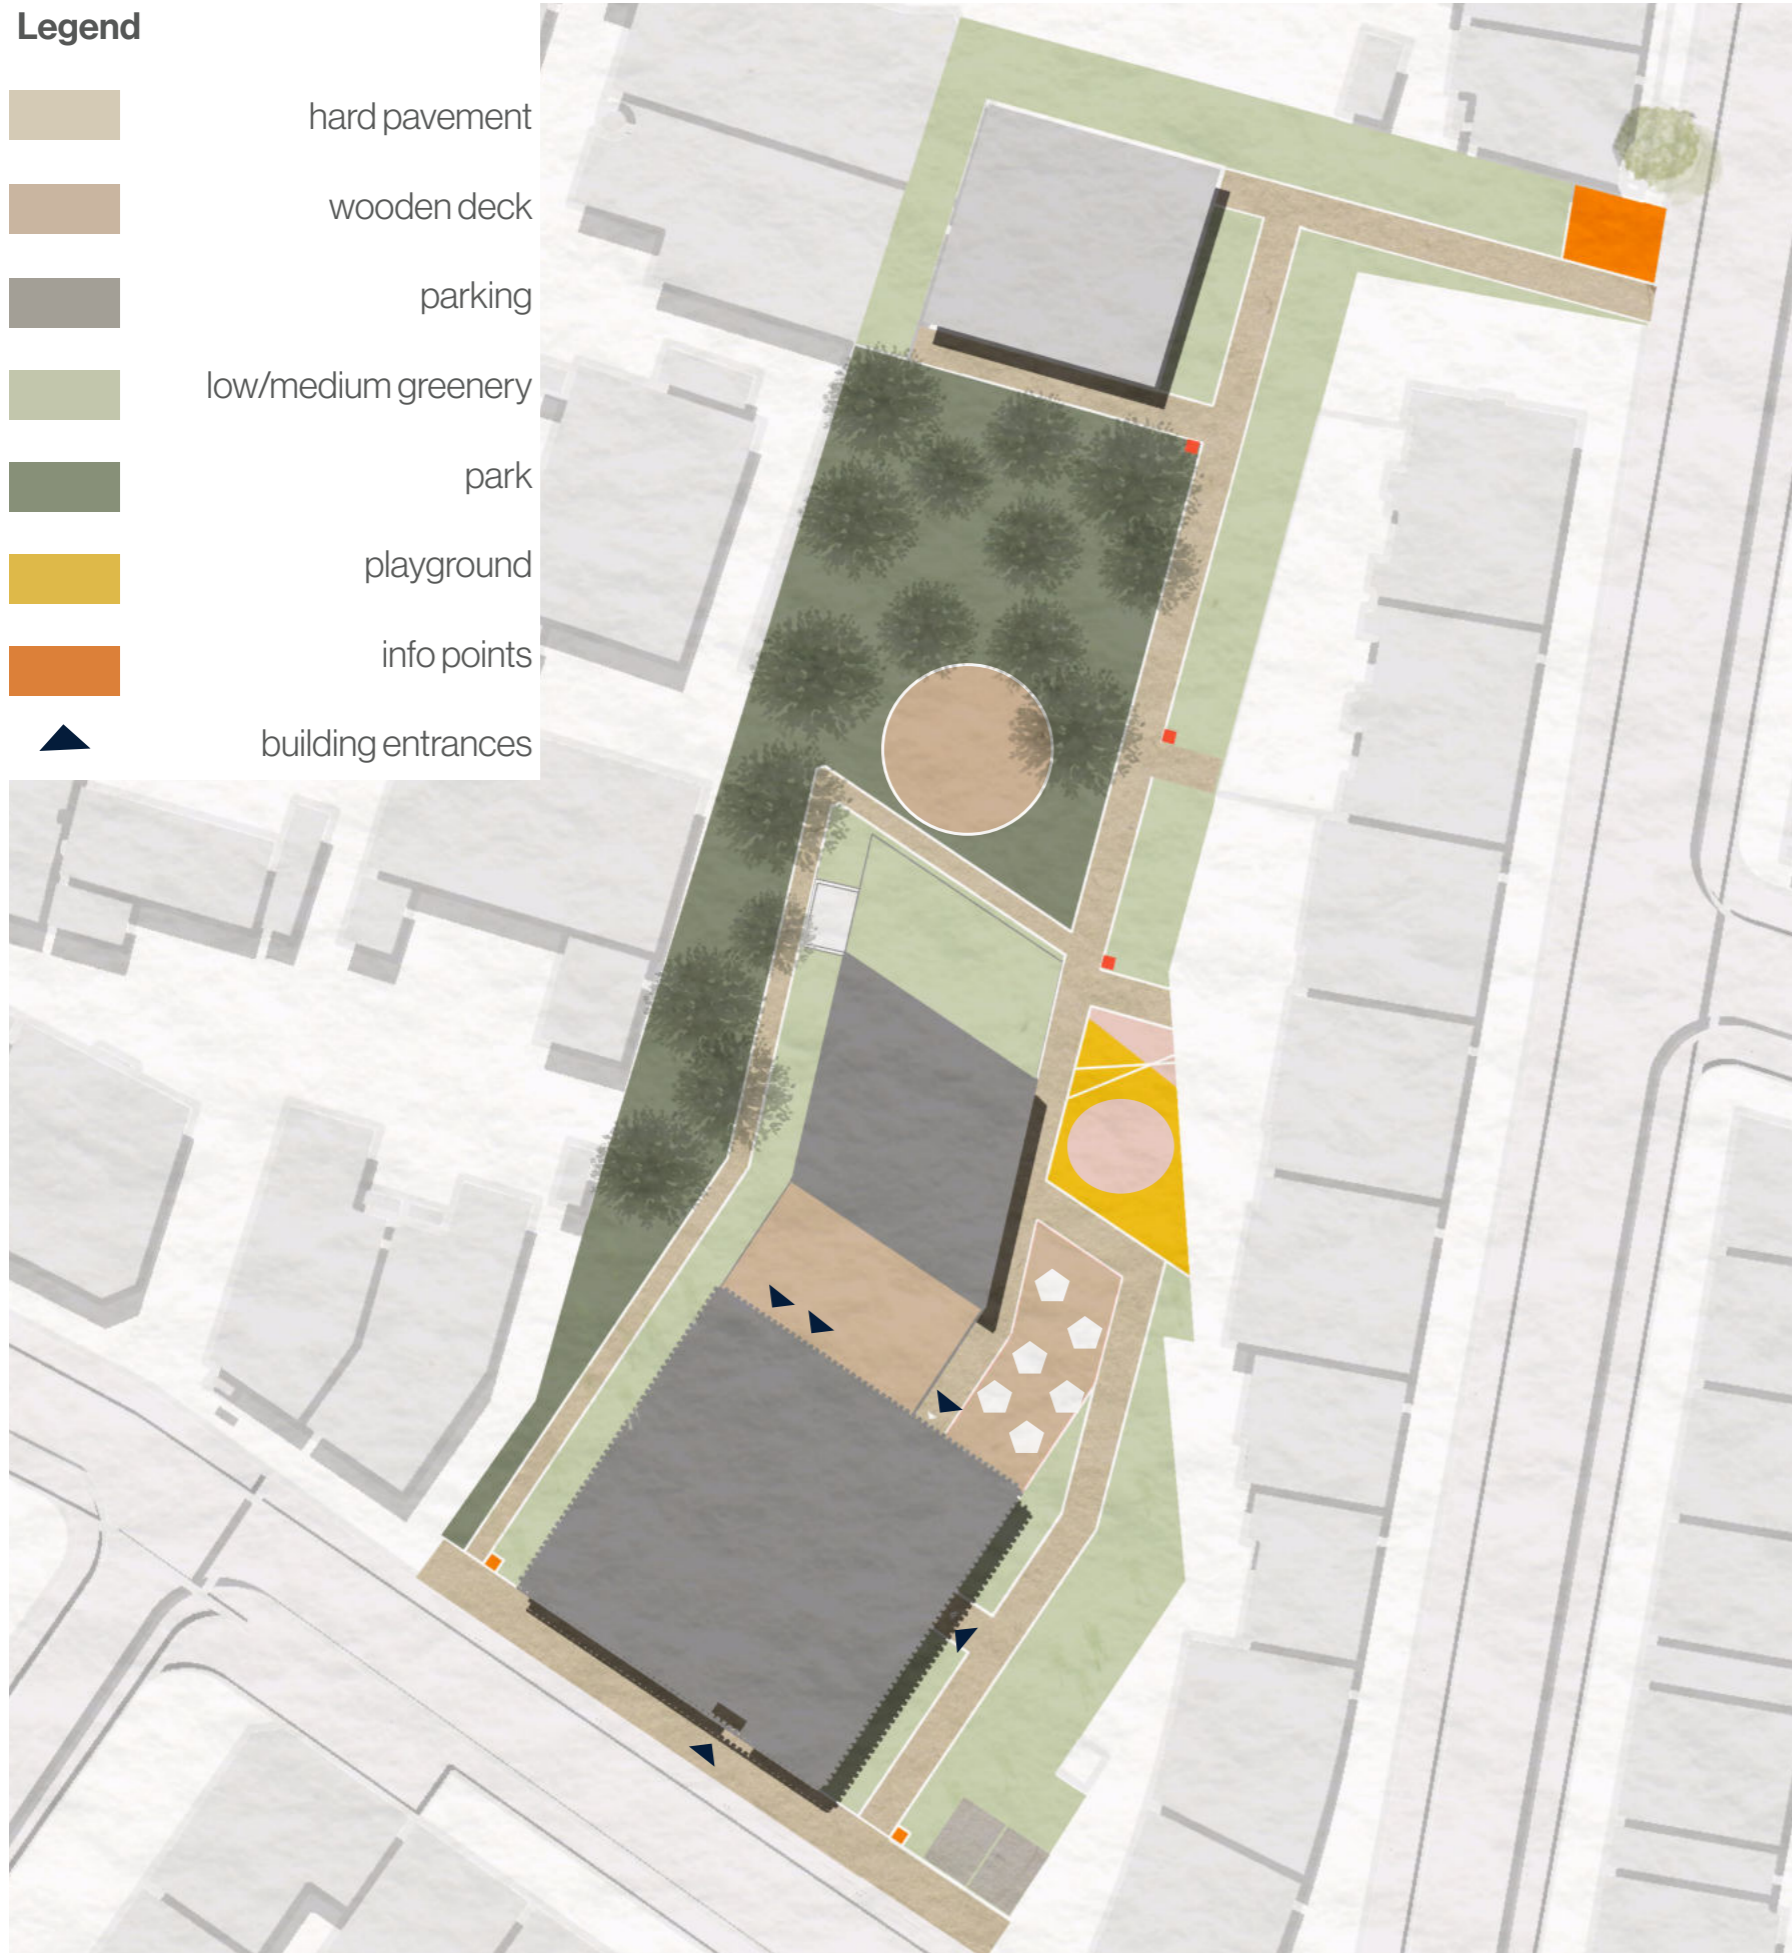
site plan scale 1:500

- hard pavement
- wooden deck
- parking
- low/medium greenery
- park
- playground
- info points
- building entrances

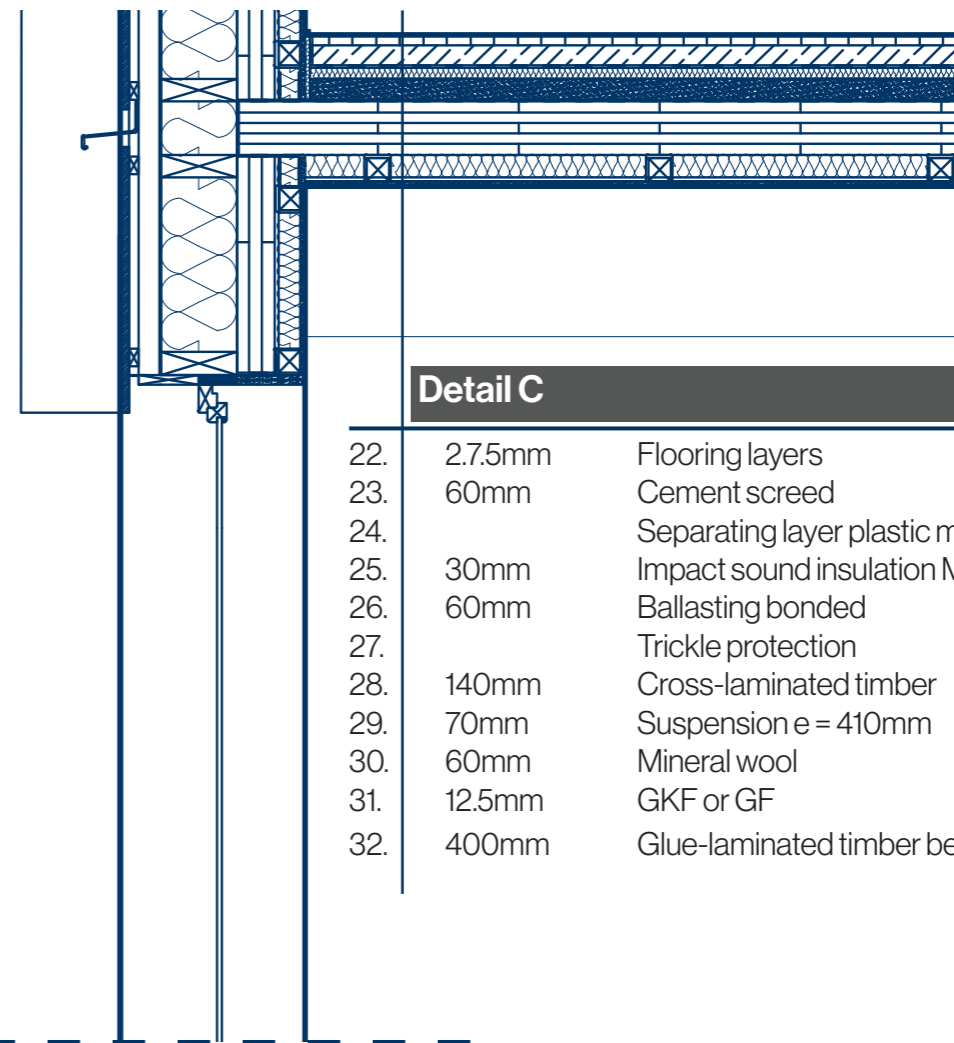
Detail C

| 22. | 2.75mm | Flooring layers |
| 23. | 60mm | Cement screed |
| 24. | | Separating layer plastic material |
| 25. | 30mm | Impact sound insulation MW-T |
| 26. | 60mm | Ballasting bonded |
| 27. | | Trickle protection |
| 28. | 140mm | Cross-laminated timber |
| 29. | 70mm | Suspension e = 410mm |
| 30. | 60mm | Mineral wool |
| 31. | 12.5mm | GKF or GF |
| 32. | 400mm | Glue-laminated timber beam |

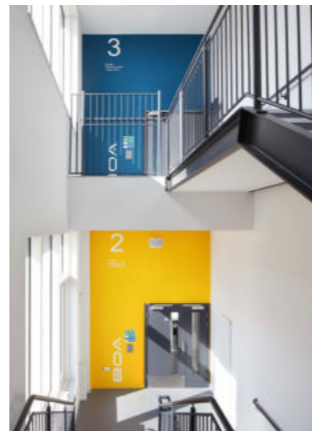
wall-integrated handle

example:

architects: Neri&Hu
 project: Bloomberg's office
 location: Hong Kong

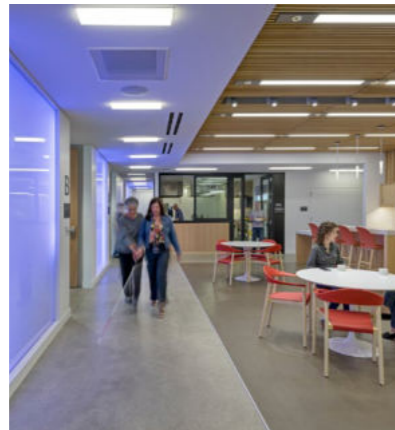
floor coverings indicating function change

example:
 architects: Mark Cavagnero Associates
 project: Lighthouse for the blind and visually impaired
 location: San Francisco, USA

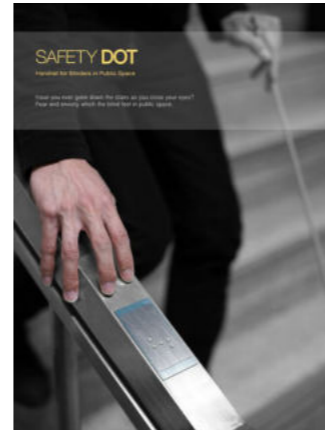
handrail signs

example:
 designers: Monocomplex & Jungjoon Hwang
 project: Safety Dot

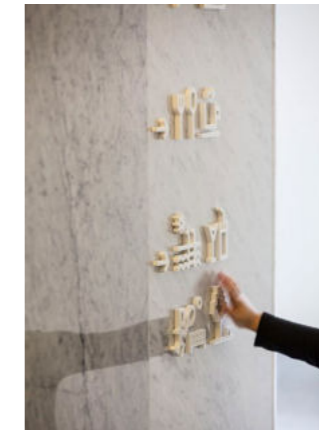
wall tactile signs

example:
 architects: Virgula
 project: Hotel Minho renovation
 location: Vila Nova de Cerveira, Portugal

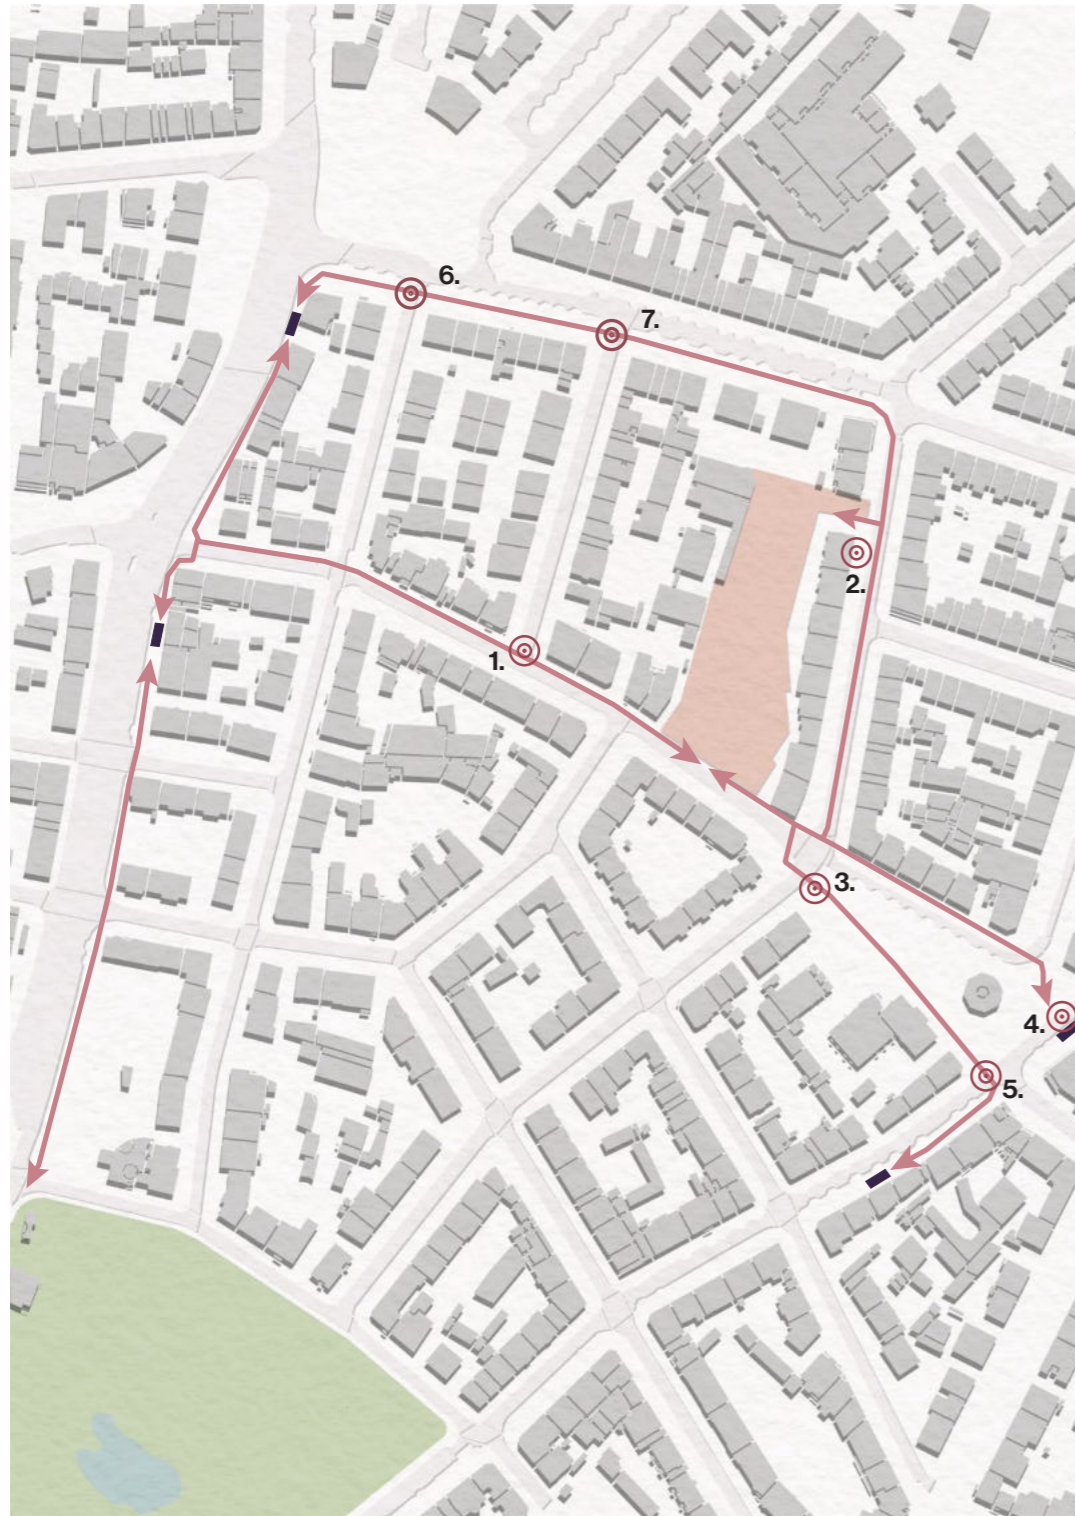
risk area 1,7
absence of fbor indicators before the pedestrian crossing

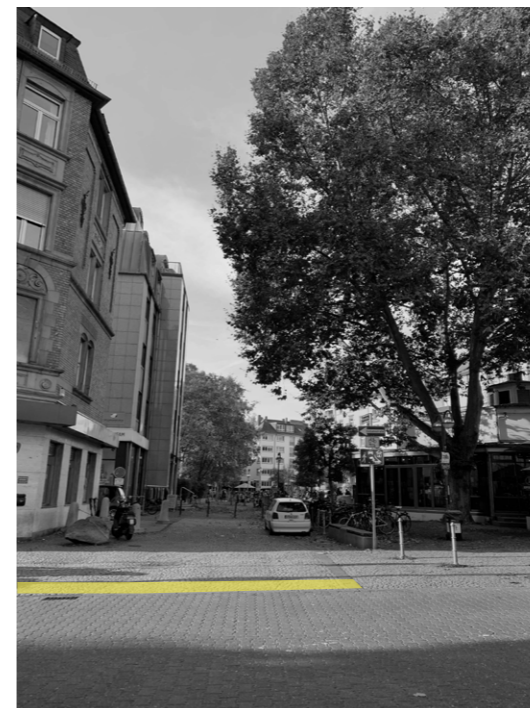
risk areas 4, 5, 6
there are two different fborings indicating crossing but no previous "warning" indicators
